Review of the Gladstone, Colorado Rainfall Observation, October 5, 1911

Ed Tomlinson, PhD, Chief Meteorologist

March, 2004

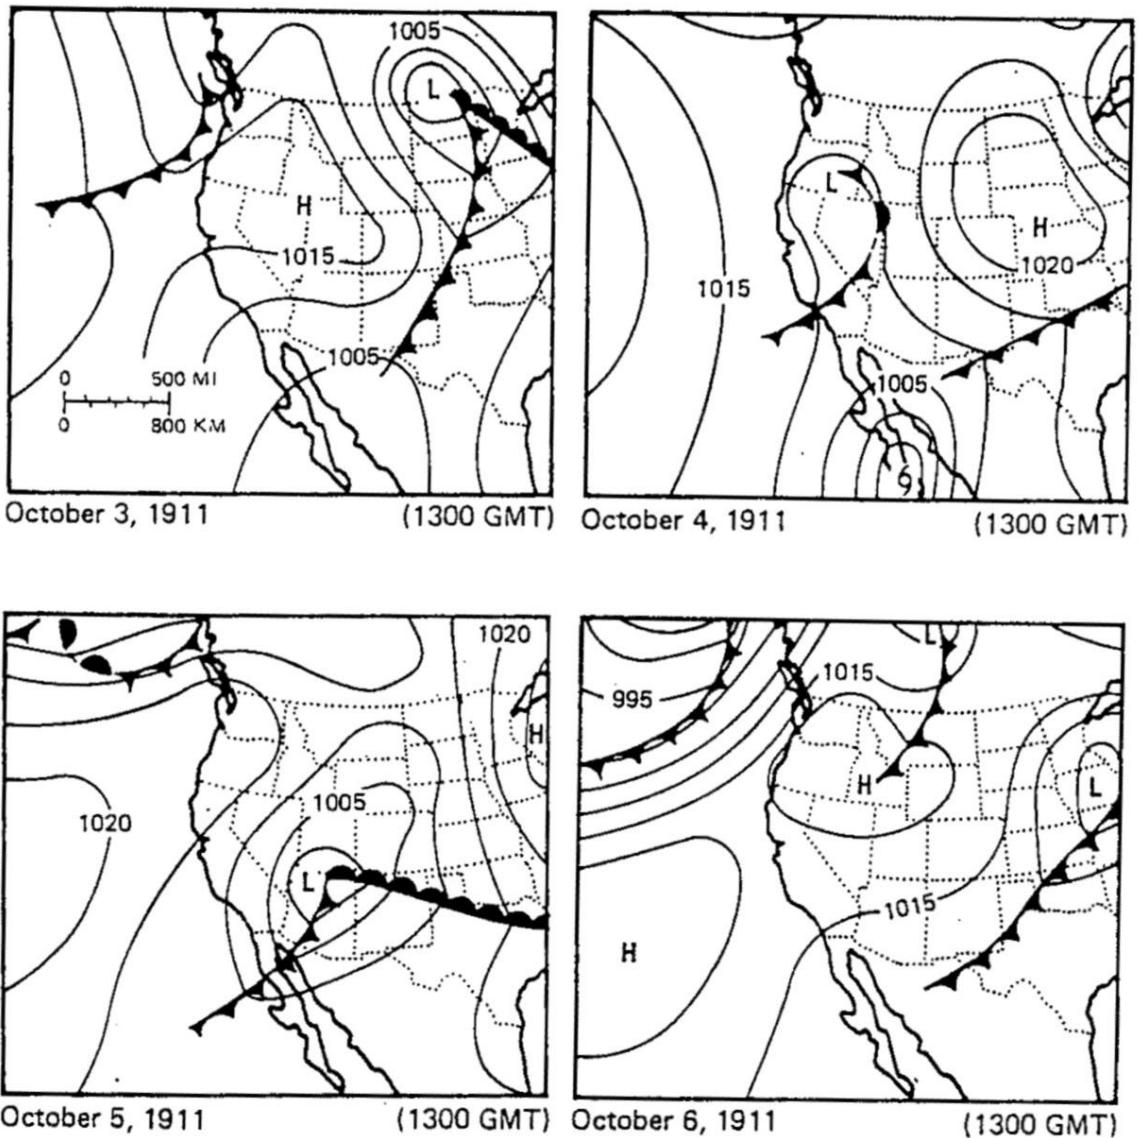
Figure 1 Surface weather maps for October 3-6, 1911 (Hansen and Schwarz,
figure 2.20, 1981)

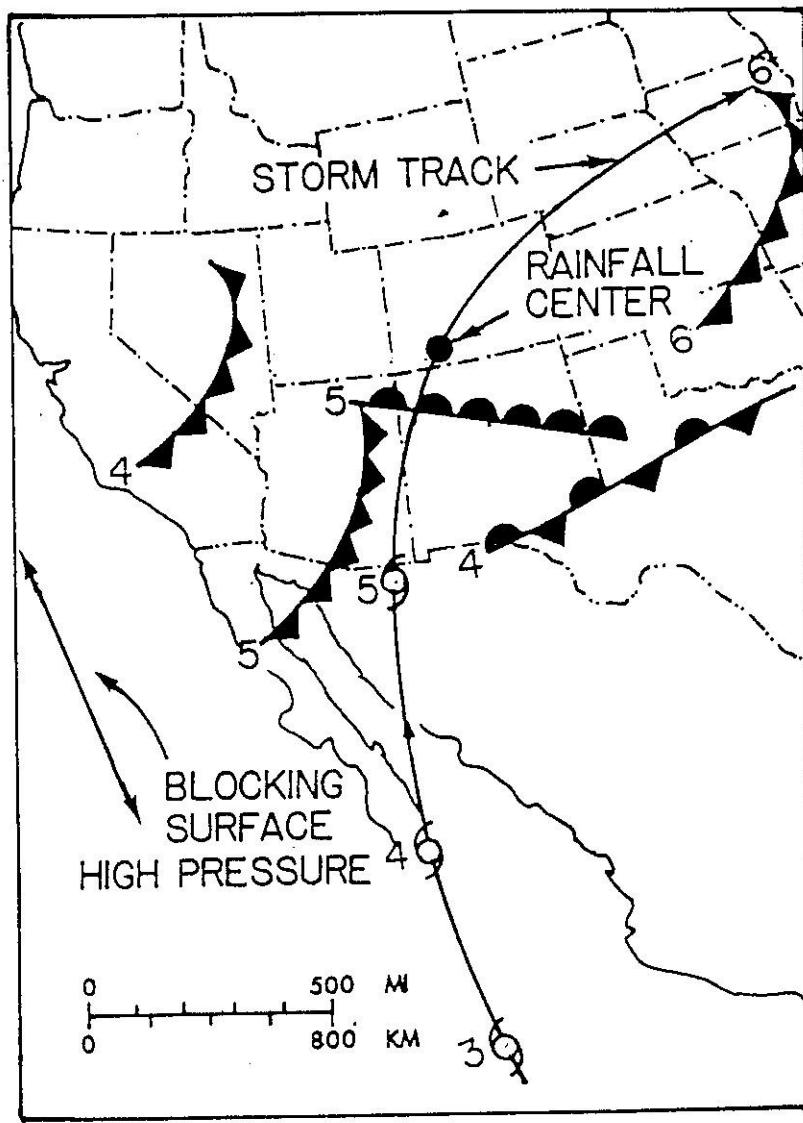
Figure 2 Storm track and significant weather features for the storm of October 4-6, 1911 (Hansen and Schwarz, figure 2.19, 1981)

Between October 4-6, 1911, a dissipating tropical storm moved northward from the tip of Baja California and through southeastern Arizona and then, after combining with an extra-tropical low pressure system, moved northeastward through central Colorado and into central Iowa (Hanson and Schwarz, 1981). Figure 1 shows the surface weather maps for October 3-6, 1911 and Figure 2 consolidates the tropical storm track with significant weather features for the storm for the period October 4-6.

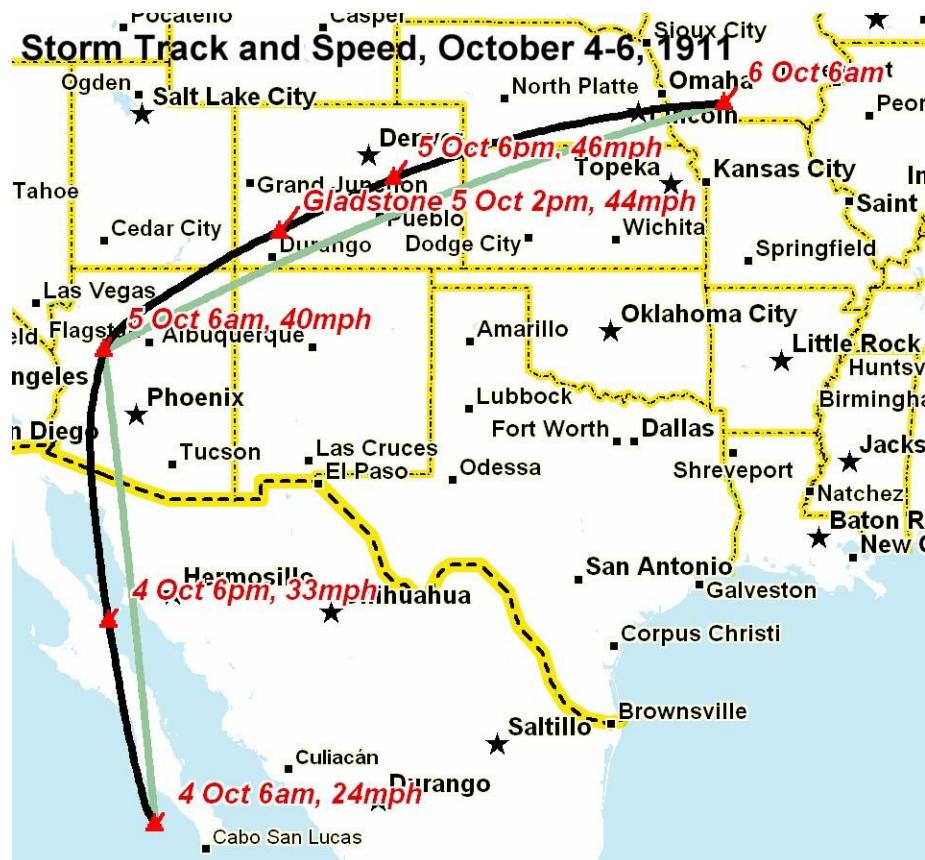
Figure 3 Approximate Storm Track and Speed, October 4-6, 1911

The average daily speeds have been confirmed using the 1300 GMT daily maps for October 3-6. Using these speeds, estimated positions have been computed for October 4th and 5th at 0100 GMT (6:00pm MST). Additionally, the time that the low pressure center would have moved over Gladstone has been estimate to be about 2:00pm on October 5th. Figure 3 shows the estimated storm locations and speeds. The green line is the straight line between locations at 1300 GMT October 4-6 and the black curved line is the estimated track of the tropical storm and the low pressure center. The storm track differs slightly from the track shown in Figure 1 because of positioning uncertainty.

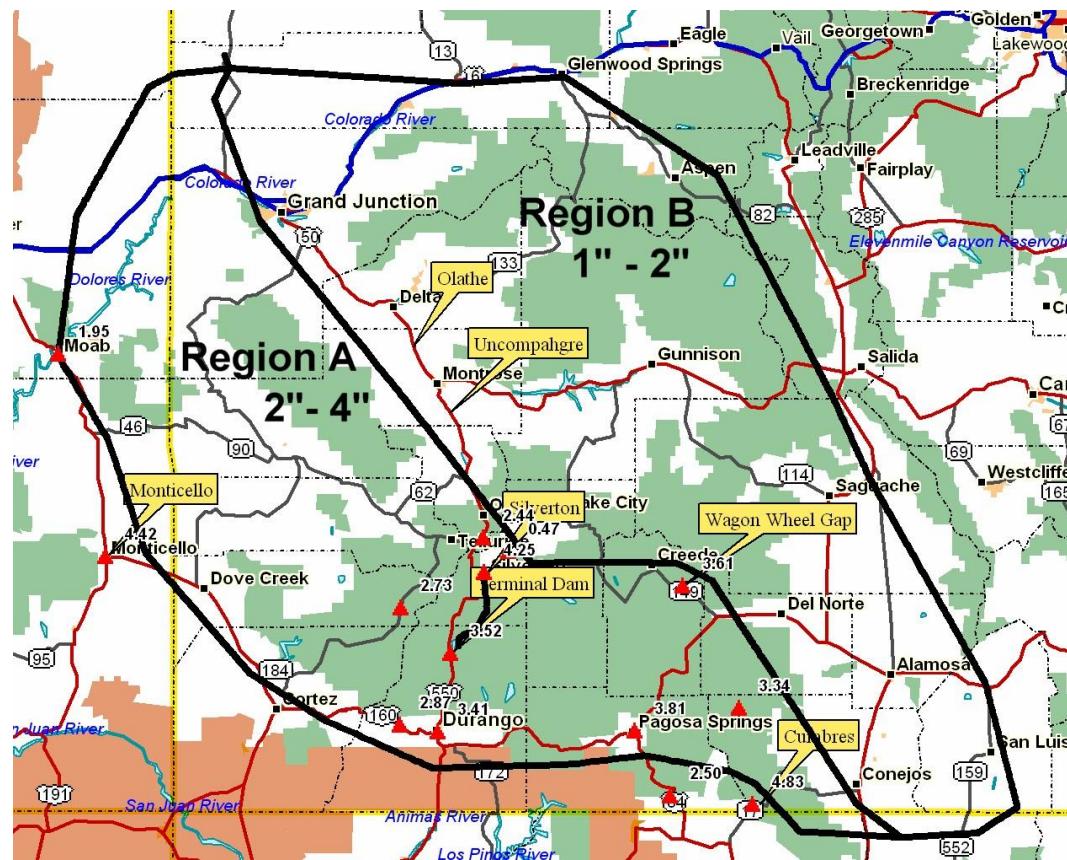
Figure 4 Locations with the largest reported rainfall totals and generalized regions of rainfall amounts

Storm rainfall totals of two inches or more were produced at locations in eastern Arizona, southwestern Colorado and northern New Mexico. Figure 4 shows the region where generally 2 inches to 4 inches of rain was observed and the region where generally 1 inch to 2 inches of rain fell. There were individual stations within each region with slightly more or less rainfall. Stations in Region A are generally exposed to southerly wind flows whereas stations in Region B generally have significant moisture barriers (above 12,000 feet) to the south. Most stations are affected by the surrounding topography.

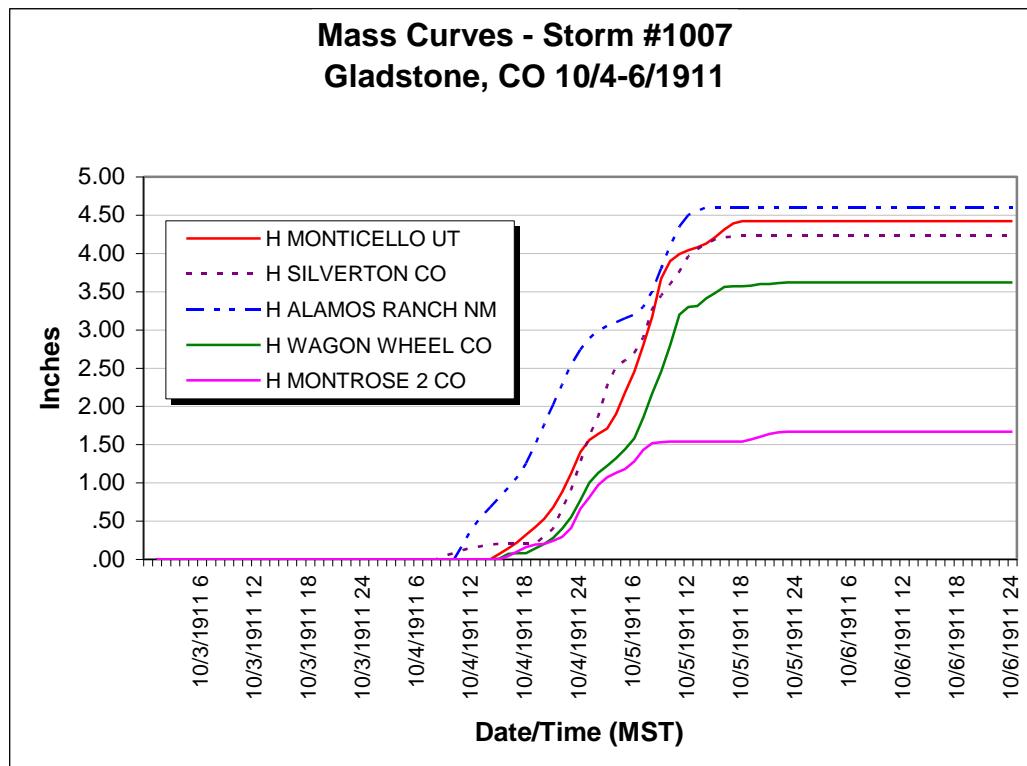
Figure 5. Mass curves for various rainfall observation locations

The rain start/stop times at various hourly locations are shown in the mass curve presented in Figure 5. It is clear that the storm system moved up from the south, hit Alamos Ranch, NM first then hit Silverton and Monticello, UT at about the same time. Then a few hours later hit Wagon Wheel, and then finally Montrose. This progression of rainfall is what would expect from the storm track shown in Figure 3. All of the hourly data for this storm were extracted from Bureau of Reclamation documents received from the Colorado Climate Center.

Four rainfall analyses were used in the rainfall/runoff modeling. Each used the mass curves presented in Figure 5. for timing of the rainfall. The first case used a previously analyzed isohyetal pattern while the other three cases used the AWA Storm Precipitation Analysis System (SPAS) isohyetal patterns. The four cases are as follows:

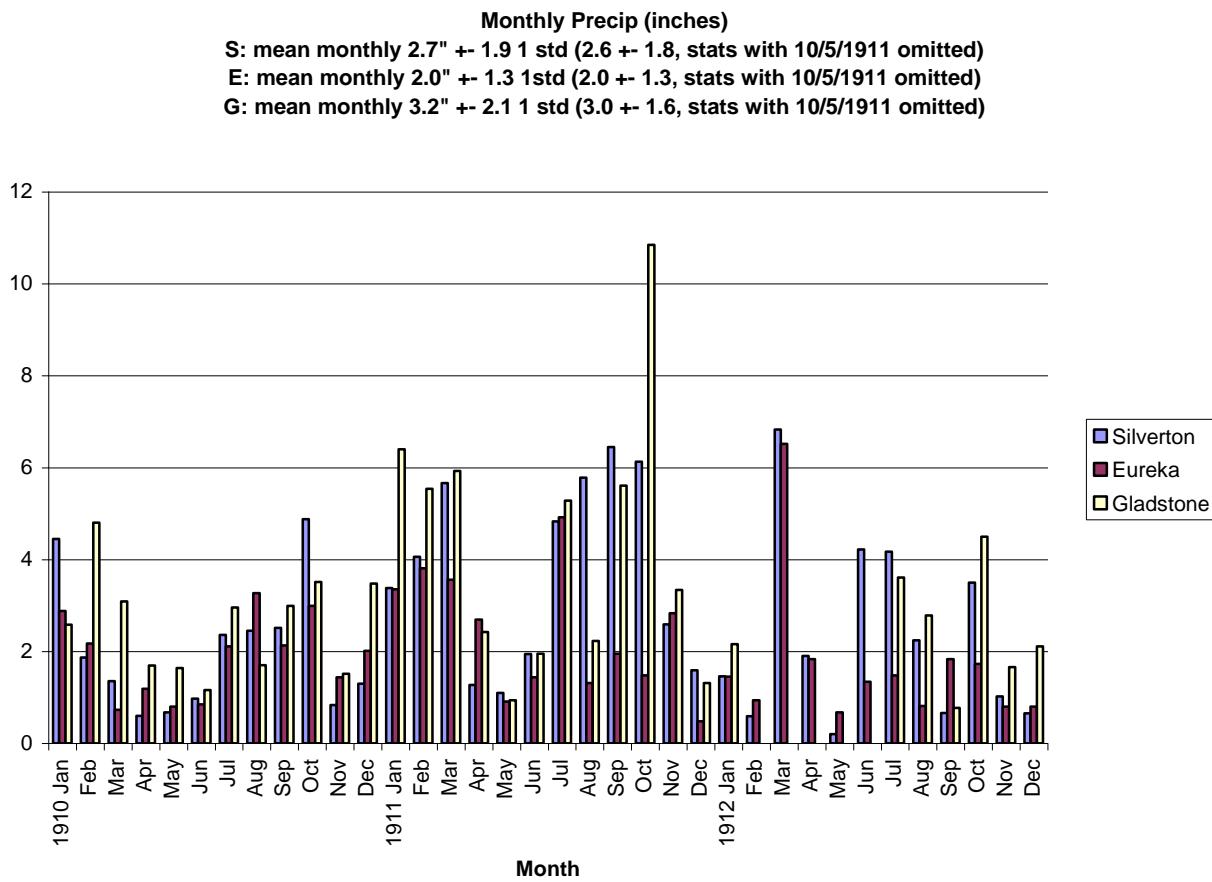
Figure 6. Monthly precipitation for Silverton, Eureka and Gladstone for 1910 through 1912. Monthly reports from Gladstone are missing from February through June 1912.

Rainfall reports from Silverton, Gladstone, and Eureka from 1910 through 1912 were reviewed. The monthly values are shown in Figure 6. and the accumulated rainfall totals for the period January 1910 through January 1911 are shown in Figure 7. Figure 6. shows that Gladstone generally reported more rainfall than Eureka (27 months vs 4 months) but October was the only month that show an extremely large difference. Figure 7. shows that Gladstone rainfall totals for 1910 through 1911 were consistently larger than Eureka rainfall totals with Silverton reporting rainfall totals between the two.

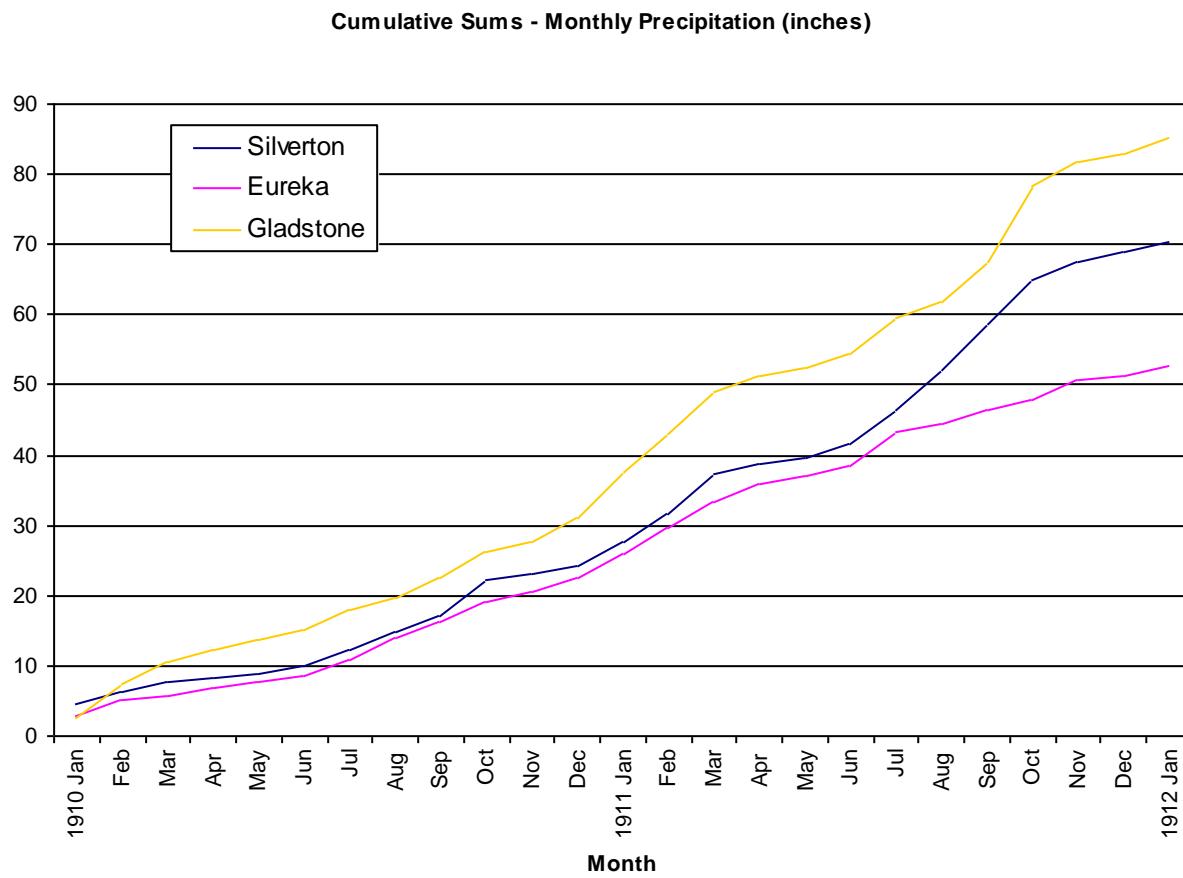
Figure 7. Cumulative rainfall totals for Silverton, Eureka and Gladstone for the period
January 1910 through January 1912.

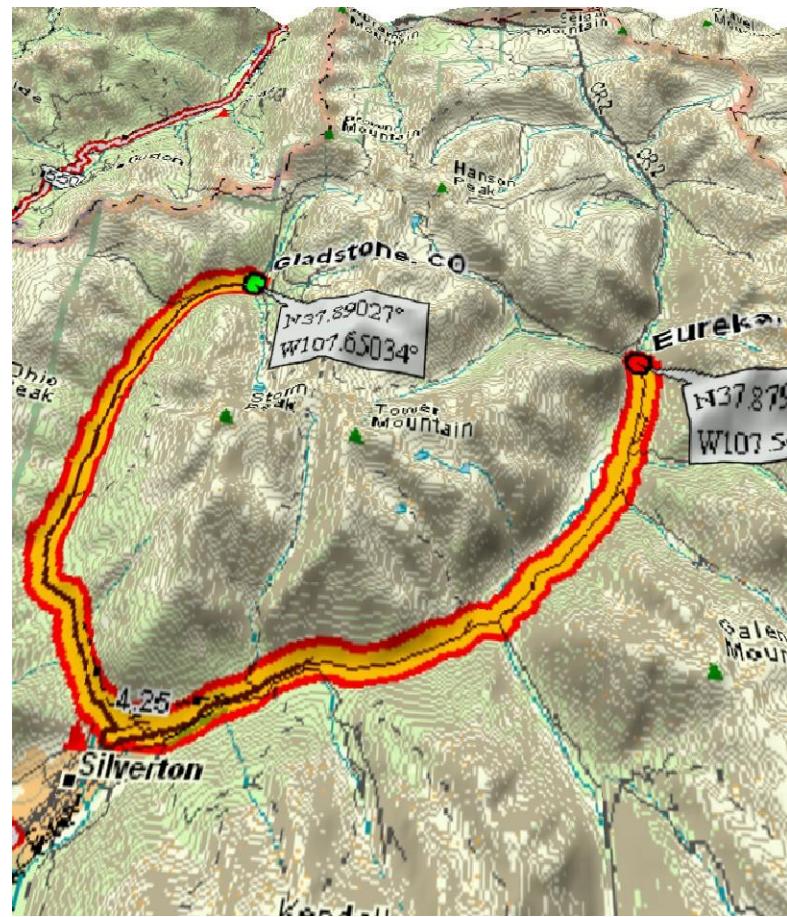
Figure 10. Route from Gladstone to Eureka via the roadway, the distance is approximately 15 miles

Copies of the observation forms from Gladstone and Eureka for October, 1911 are shown in Figures 8 and 9. Both forms are initialed by someone with the initials E.F.B. and stamped with the date Nov 12, 1911. Possibly this person prepared the forms for The San Juan Water and Power Co. for both Gladstone and Eureka using information provided by the observers at each location. Other monthly observation forms for 1910 through 1912 for Silverton, Eureka and Gladstone have the same initials. All of the forms were typed and appeared to be diligently filled out. Traces were even entered. It appears unlikely that this person made the observations at both locations each day since although the locations are less than 5 miles apart, the distance along the roadway is almost 15 miles. Figure 10 shows the roadway distance between Gladstone and Eureka.

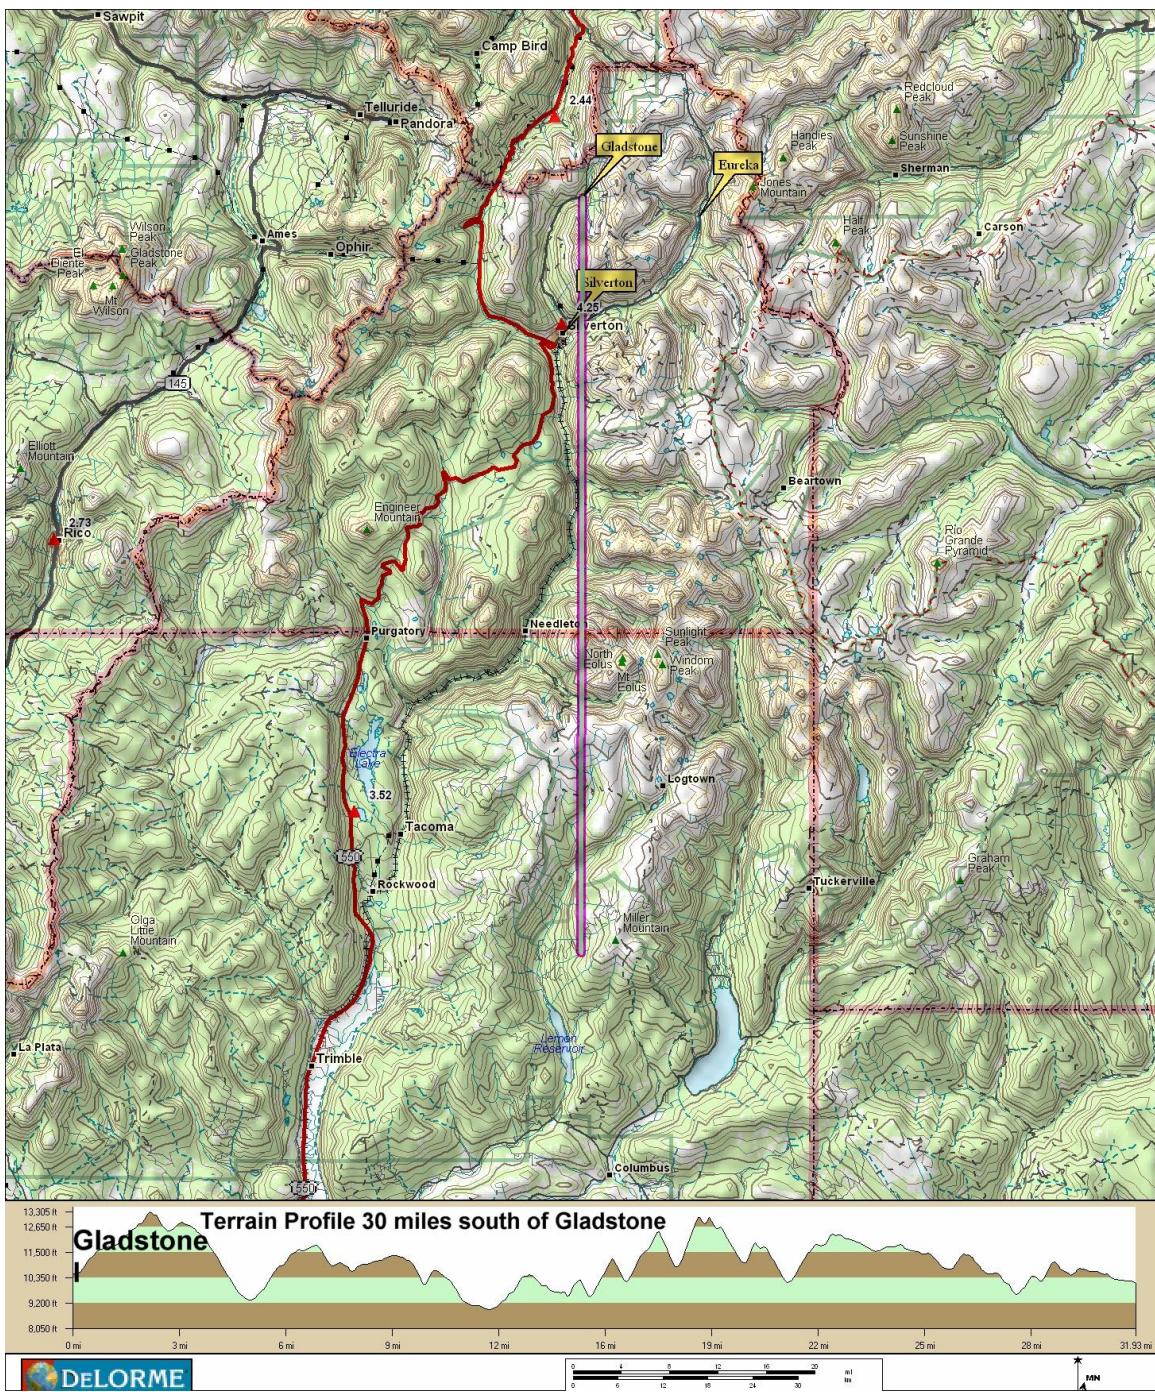
Figure 11. Map Showing Topography Surrounding Gladstone and the Terrain Profile to the South of Gladstone

Figures 11 – 13 show terrain profiles directly south of the three locations. Each profile shows relatively high terrain upwind under southerly wind flow conditions. Additionally, the profiles show steep downslope conditions immediately upwind of Gladstone and Eureka. Figures 14 – 16 provide three-dimensional views of the terrain along with inflow vectors for the south-southeast, south and south-southwest directions. While the terrain upwind of Gladstone and Eureka is fairly consistent with elevations between 12,000 feet and 13,000 feet, the terrain south of Silverton contains the Animas River valley, oriented roughly south to north. Figures 17 shows a photo taken from a half mile north-northeast of Gladstone looking to the south-southwest and Figure 18 shows a photo taken from Gladstone looking to the south. Figure 19 shows the Animas River valley profile south of Silverton. The Animas River valley has limited horizontal width but provides a path for atmospheric moisture to move northward to Silverton without a significant moisture barrier. Although there is a major topographic barrier between Silverton and Gladstone and between Silverton and Eureka, a limited amount of

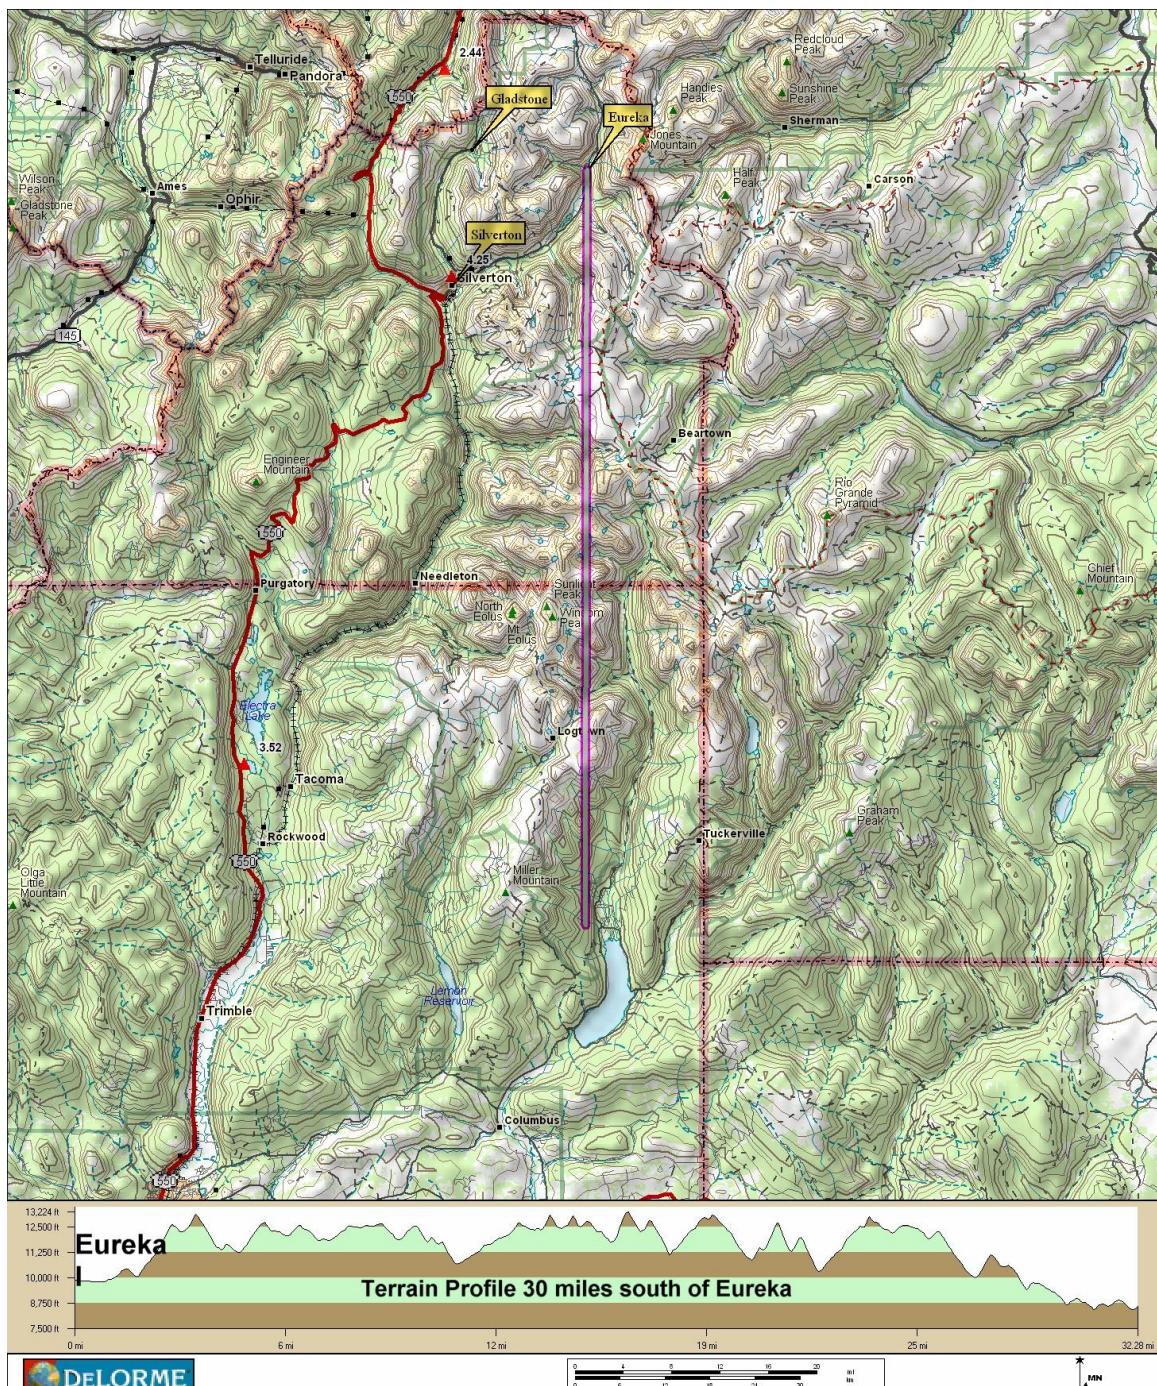
Figure 12. Map Showing Topography Surrounding Eureka and the Terrain Profile to the South of Eureka

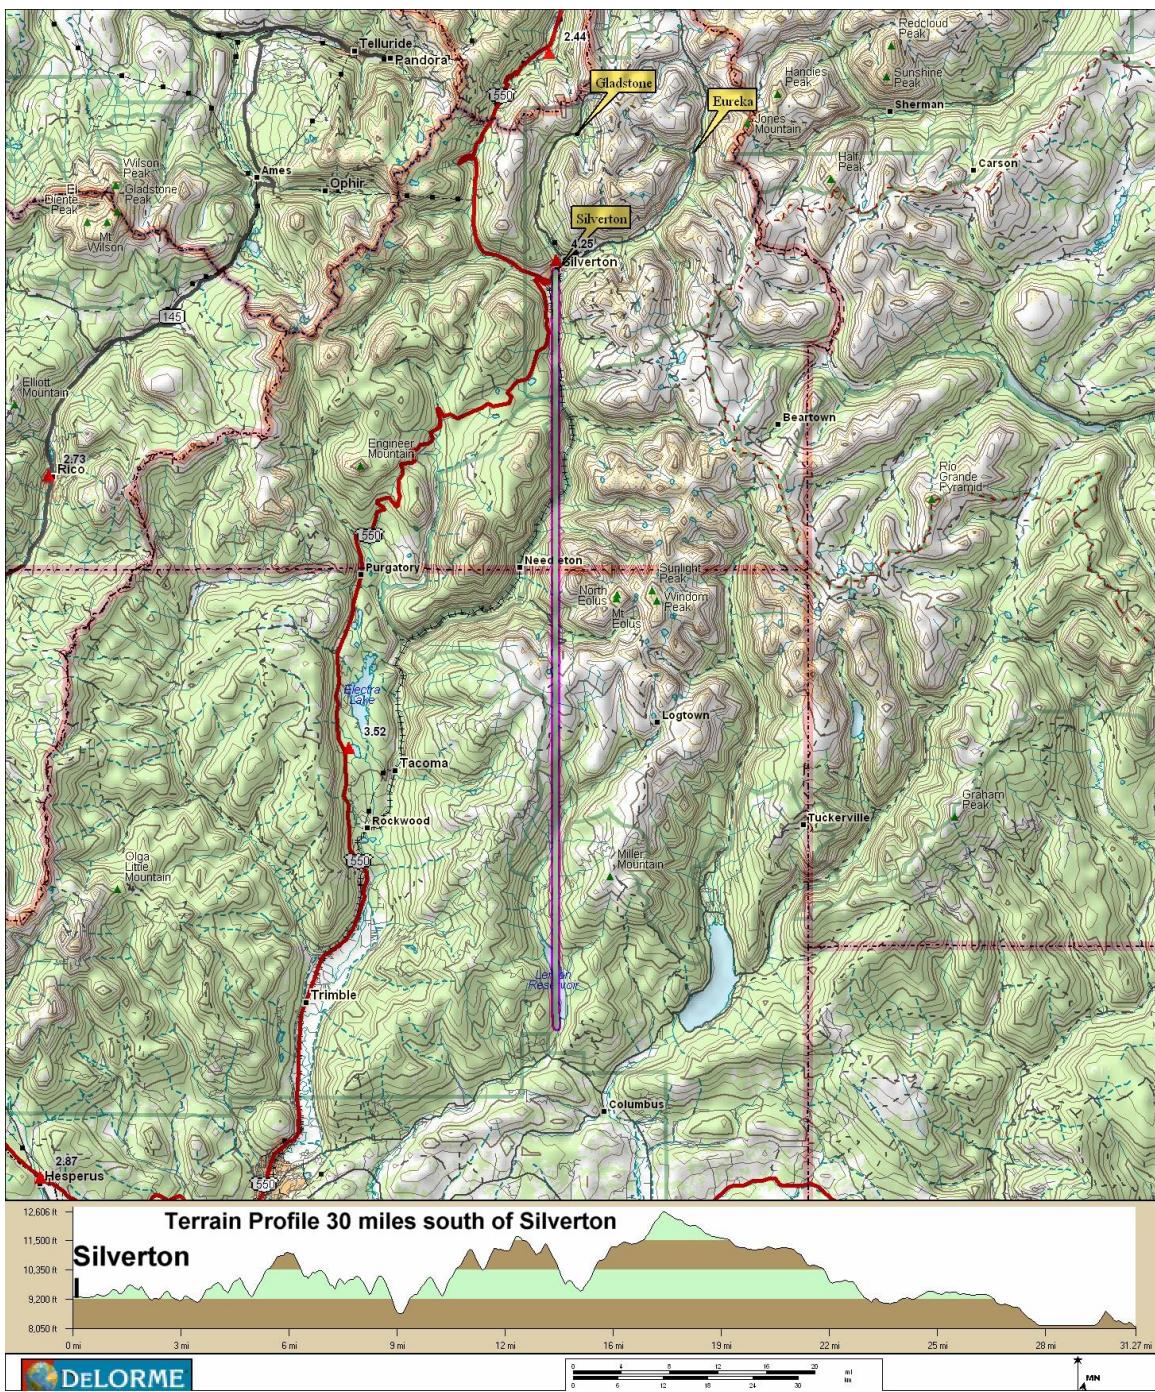
Figure 13. Map Showing Topography Surrounding Silverton and the Terrain Profile to the South of Silverton

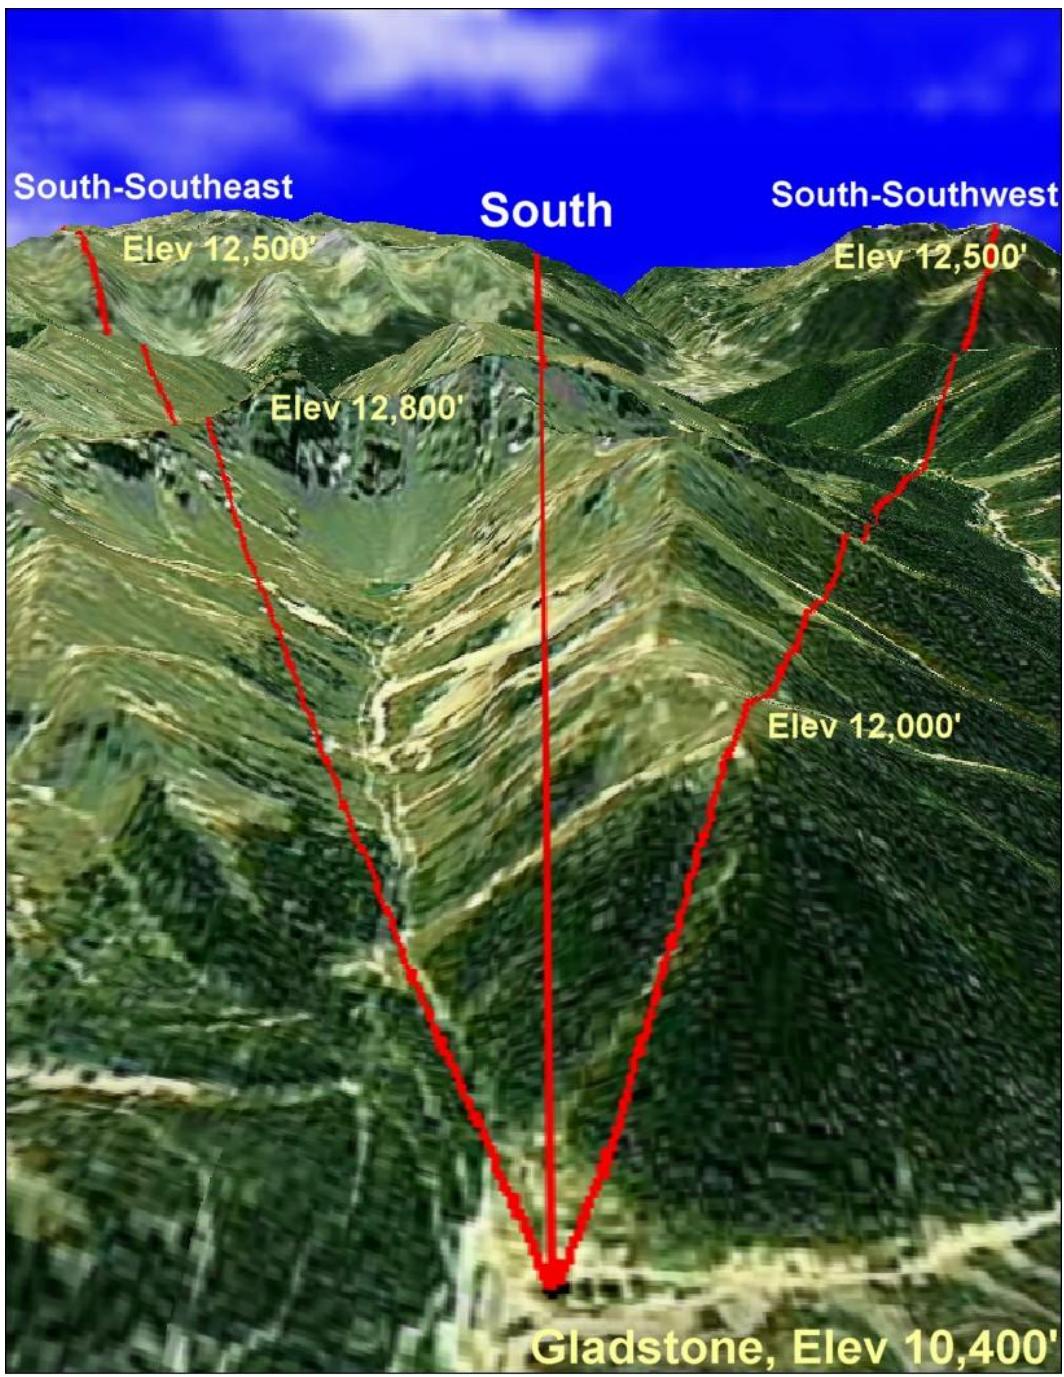
Figure 14. Three-dimensional View of the Terrain South of Gladstone with Inflow Vectors for the South-Southeast, South and South-Southwest Directions

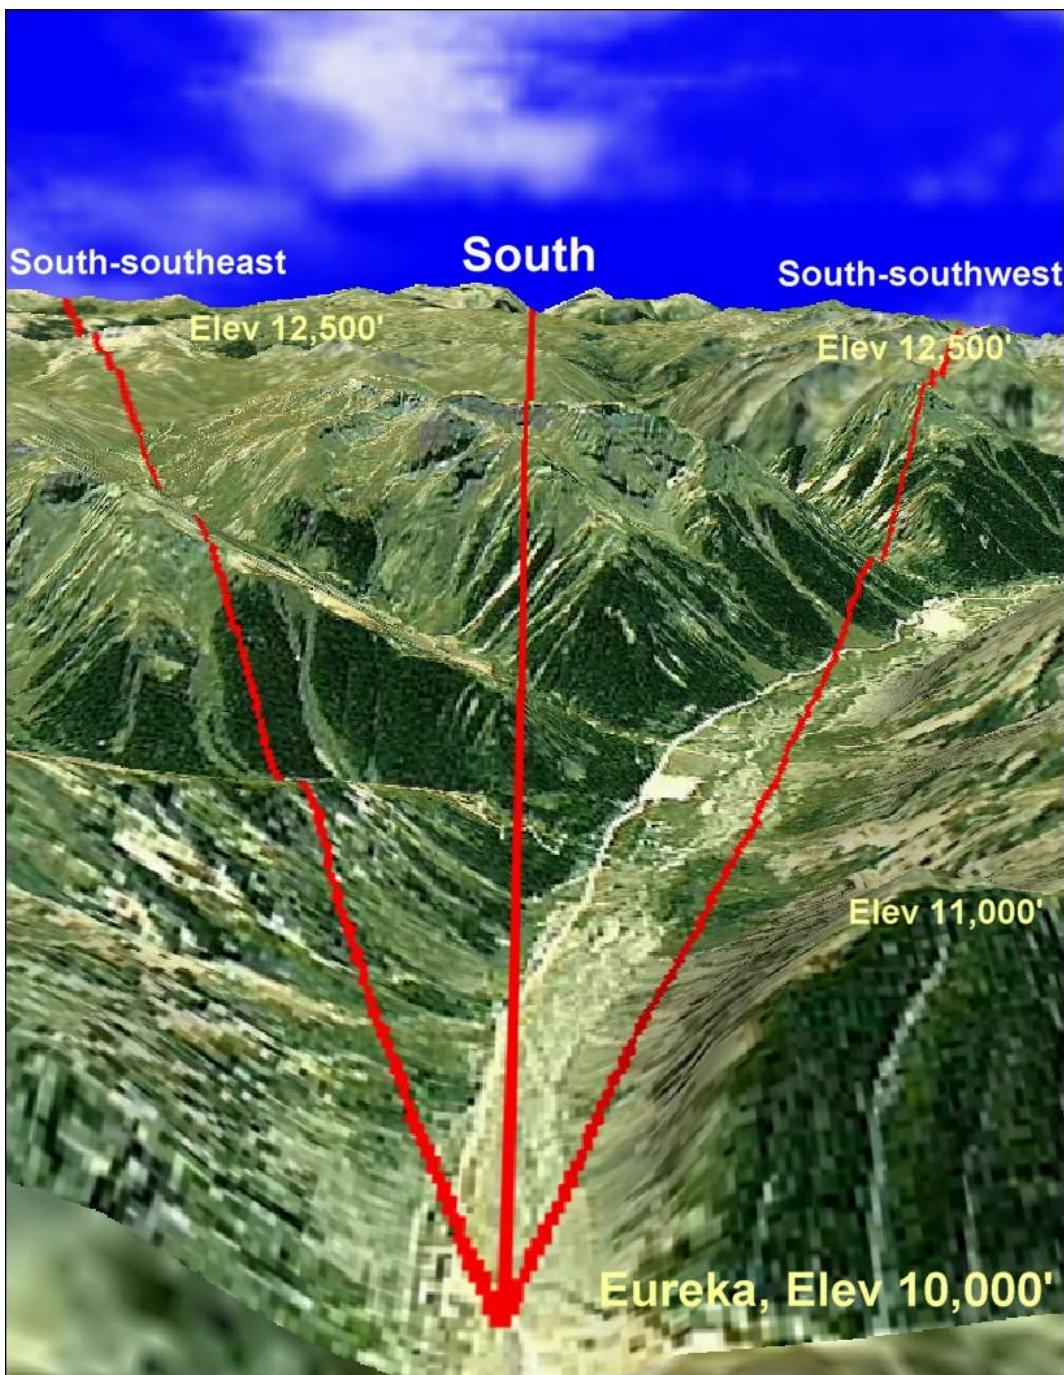
Figure 15. Three-dimensional View of the Terrain South of Eureka with Inflow Vectors
for the South-Southeast, South and South-Southwest Directions

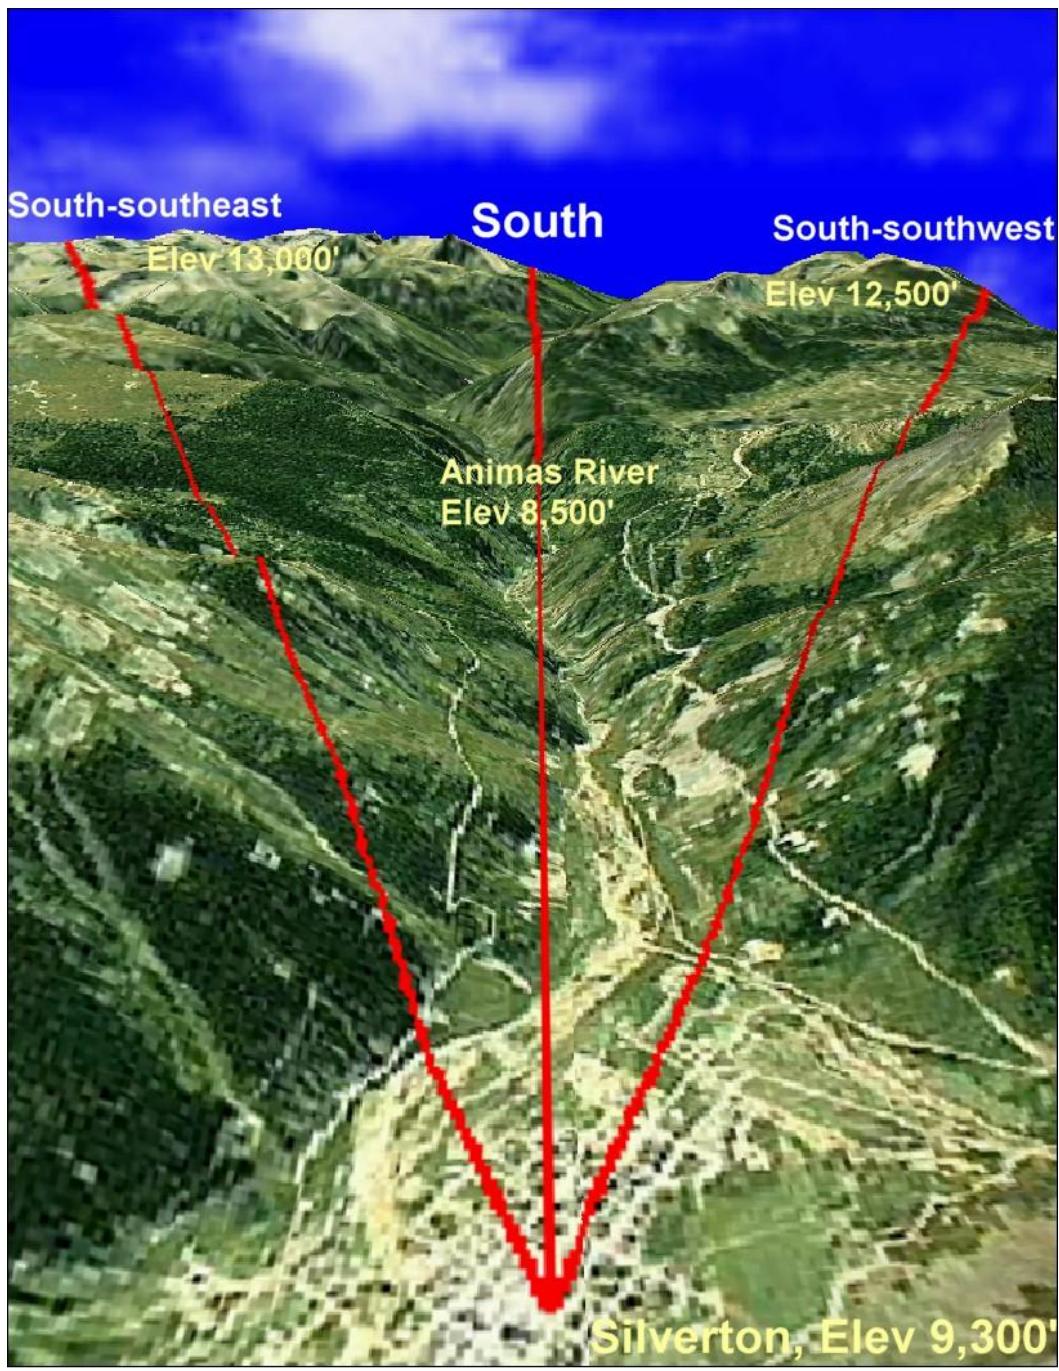
Figure 16. Three-dimensional View of the Terrain South of Silverton with Inflow Vectors for the South-Southeast, South and South-Southwest Directions

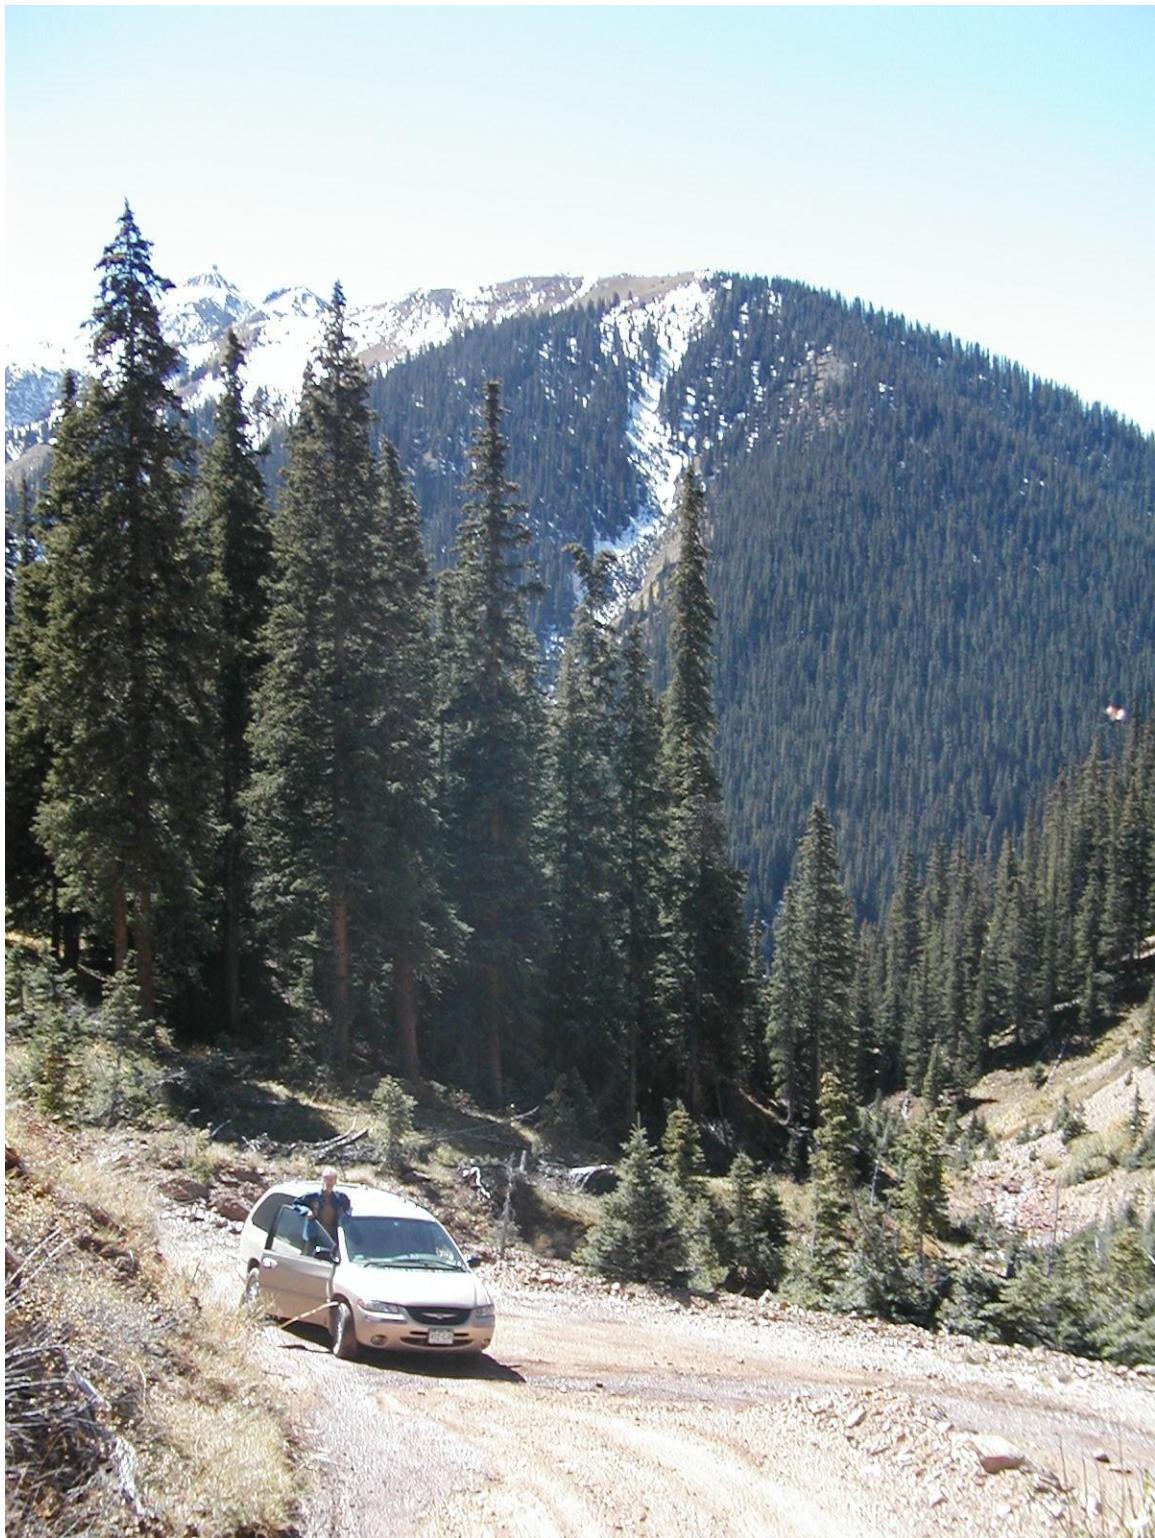
Figures 17. Photo taken from 0.5 miles north-northeast of Gladstone looking south-southwest, September, 2003.

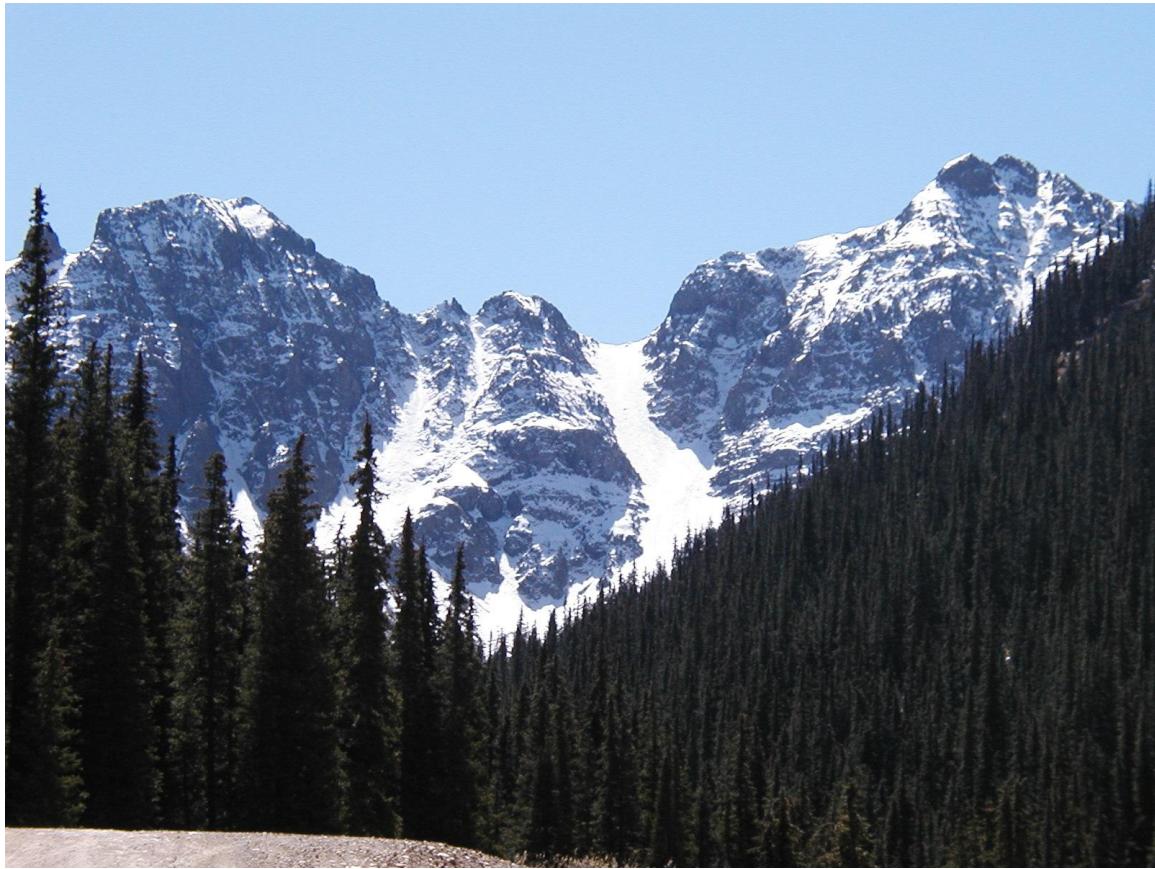
Figure 18. Photo taken from Gladstone looking to the south, September, 2003.
Storm Peak, elevation 13,380', is on the right two miles away.

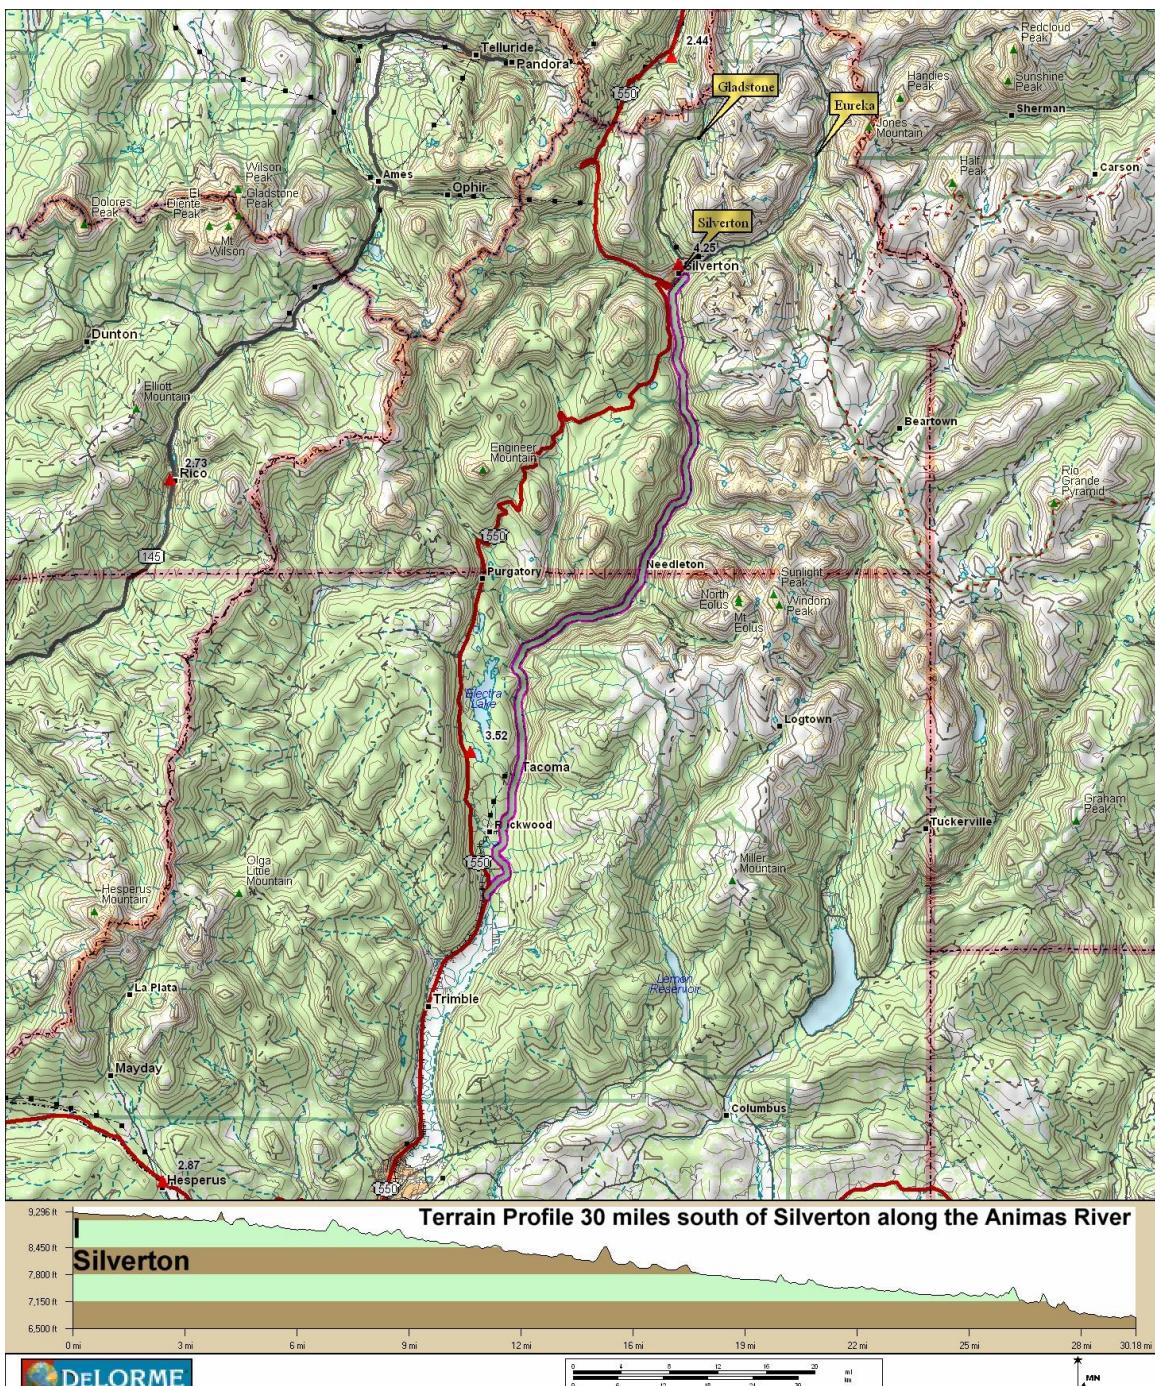
Figure 19. Map Showing Topography Surrounding Silverton and the Profile of the Animas River Valley South of Silverton
