Review of the Gladstone, Colorado Rainfall Observation, October 5, 1911

Ed Tomlinson, PhD, Chief Meteorologist

March, 2004

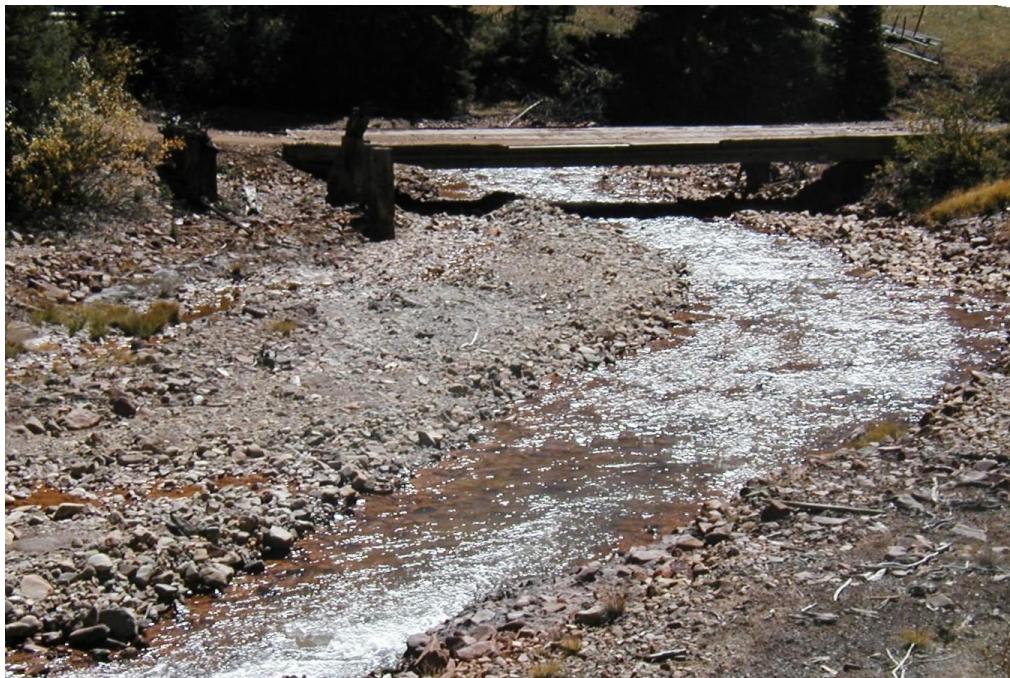
Figure 20. Bridge over Cement Creek below Gladstone, September 2003.

Railway tracks and bridges were washed out. In particular, bridges on the road to Gladstone were washed out and the road to Eureka was damaged. However, it was expected that few repairs on both of these roads would open the roads in a short time (Silverton Standard, Saturday October 7, 1911). These bridges were constructed of wood timbers and spanned streams very near the bankfull level. Figure 18 shows a picture taken in September 2003 of what is believed to be a similar bridge over Cement Creek below Gladstone. The fact that the bridges could be replaced or repaired in just a few days indicate that the flows were not much greater than bankfull and/or the destruction may not have been total (Pruess, 1996).

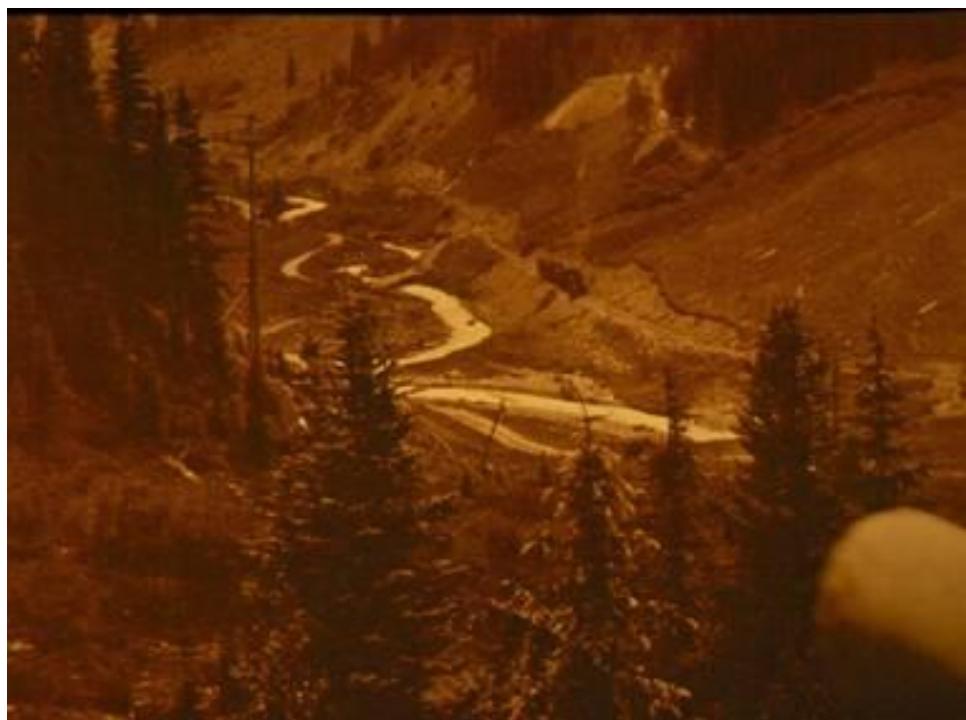
Figure 21 Cement Creek near Gladstone, 1912 (Sundance Publishing, Ltd.)

Photographs taken in 1912 show Cement Creek in Silverton and near Gladstone. One of these photos shows a locomotive moving upstream along Cement Creek toward Gladstone in 1912 (Figure 21). Evidence for the occurrence of an extreme flood in 1911 is not visible in the photograph. If substantial out-of-bank flooding had occurred, flood evidence, such as erosional or depositional features should be noticeable in the 1912 photos. The existence of established willows that encroached upon the channel and a small bar deposit that does not represent significant overbank flooding is evidence that the flood of 1911 was not extreme. Another 1912 photograph of Cement Creek flowing through Silverton shows slackwater deposits, woody debris on the tops of in-channel flood bars and depositional surfaces beyond the present channel (Figure 22). However, the evidence in the photograph does not indicate that any substantial out-of-bank flooding occurred in 1911 (Pruess, 1996). Pruess arrived at two definite conclusions based on the historical information:

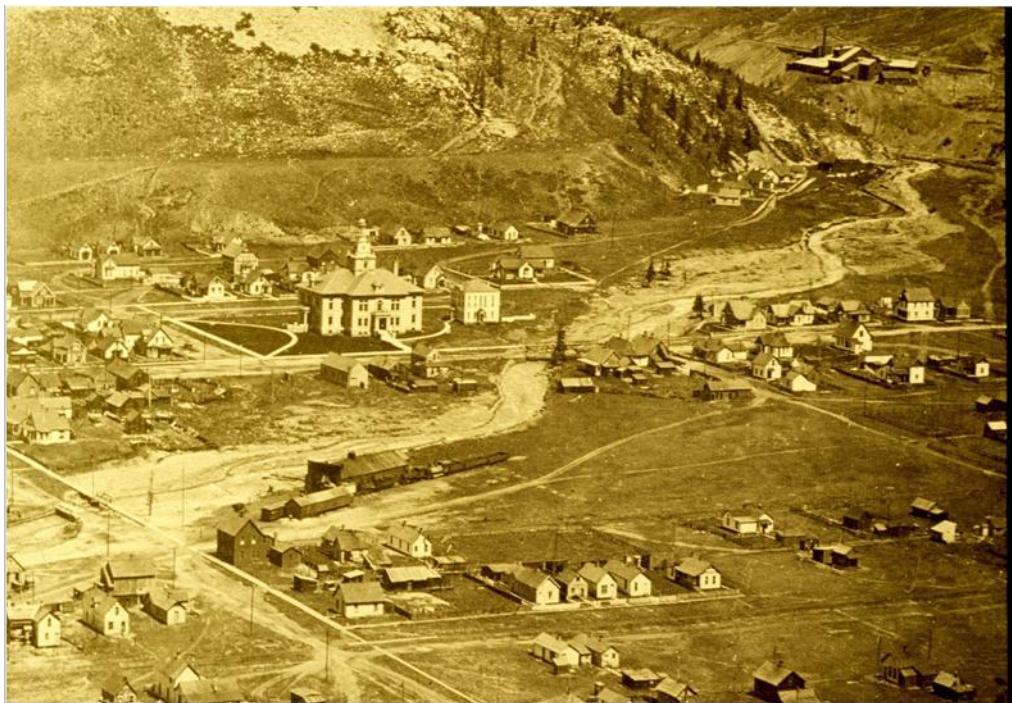
Figure 22. Cement Creek at Silverton, 1912 (Sundance Publishing, Ltd.)

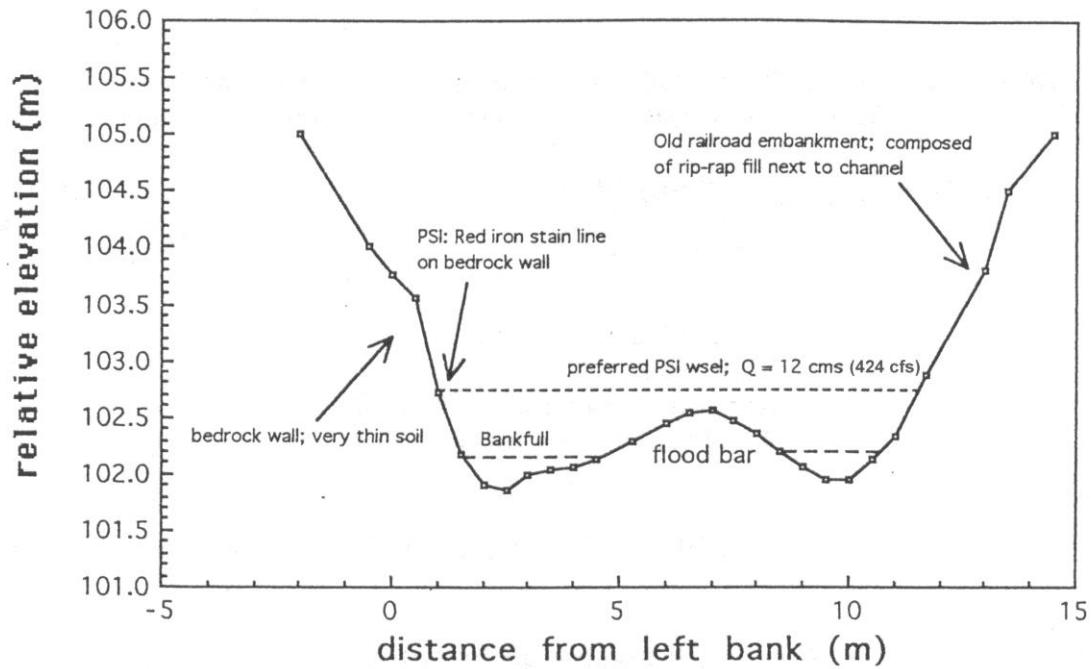
Figure 23. Preferred Water-Surface Elevation for the Cement Creek Paleoflood Site (Pruess, 1996)

Pruess computed the preferred water-surface elevation at this site using the cross section in Figure 23 and a step-backwater analysis. The computed preferred discharge is 424 cubic feet per second (cfs).

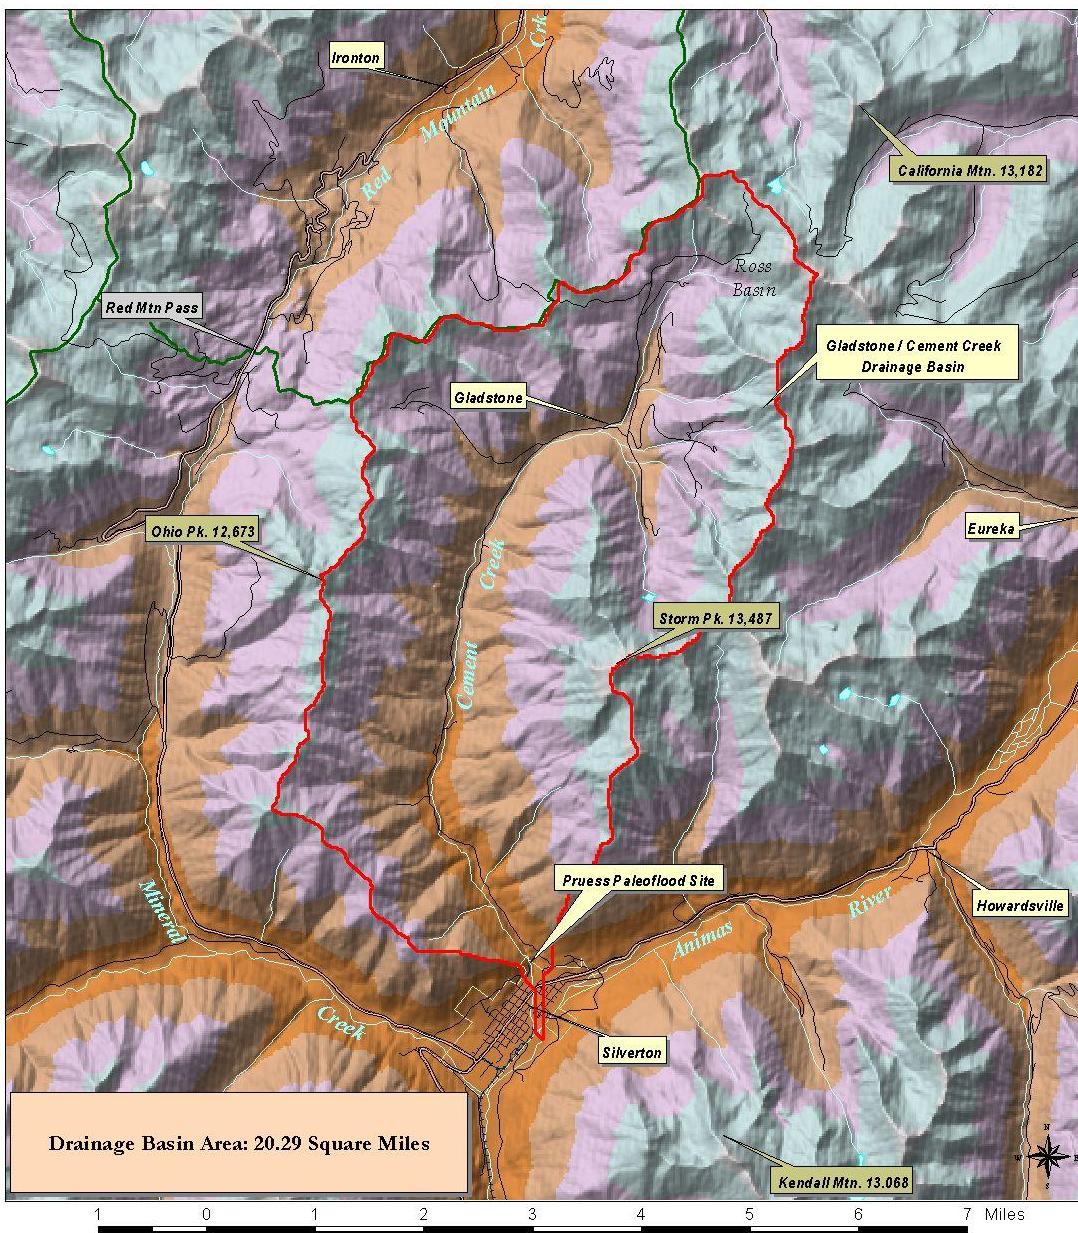
Gladstone / Cement Creek Drainage Basin Map
Silverton Mining District, Colorado

Figure 24. Cement Creek Drainage Basin Map

Jarrett and Pruess collected detailed paleoflood data for several locations in the region from Gladstone and Eureka down the Animas River towards Durango. One of those sites is on Cement Creek, 0.4 kilometers upstream of the Greene Street bridge in Silverton. This location is very close to where Cement Creek enters the Animas River (Pruess, 1996). The location is shown on the map in Figure 24.

A Geographic Information System (GIS) Digital Elevation Model (DEM) was constructed and used to compute the drainage area for the Cement Creek basin. The DEM is presented in Figure 24. The area of the drainage basin was computed to be 20.29 square miles.

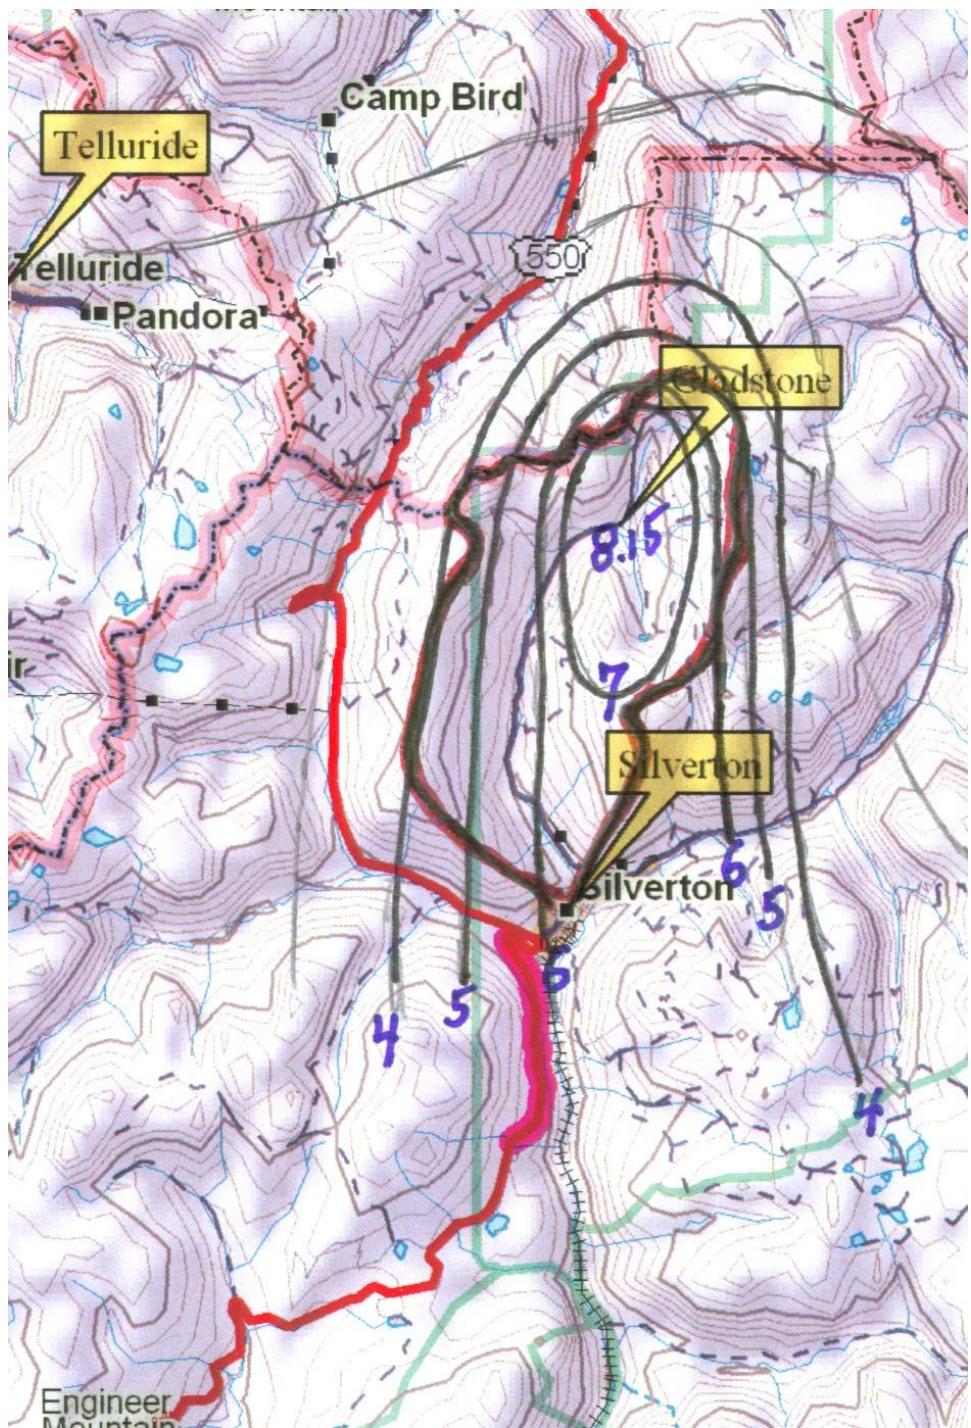
Figure 25. Adopted isohyetal pattern based on the Bureau of Reclamation isohyetal analysis (Pruess, 1996) , referred to as Gladstone "Previous"

- 1) Adopted isohyetal pattern based on the Bureau of Reclamation isohyetal analysis (Pruess, 1996), referred to as Gladstone “Previous”.
- 2) SPAS isohyetal pattern using the Gladstone observation of 8.05” on October 5 as is entered on the observation form (Figure 8), referred to as Gladstone “High”.
- 3) SPAS isohyetal pattern using a rainfall value of 0.81 for Gladstone on October 5*, referred to as Gladstone “Low”.
- 4) SPAS isohyetal pattern without either the Gladstone or Eureka observations, referred to as w/o Gladstone & Eureka.

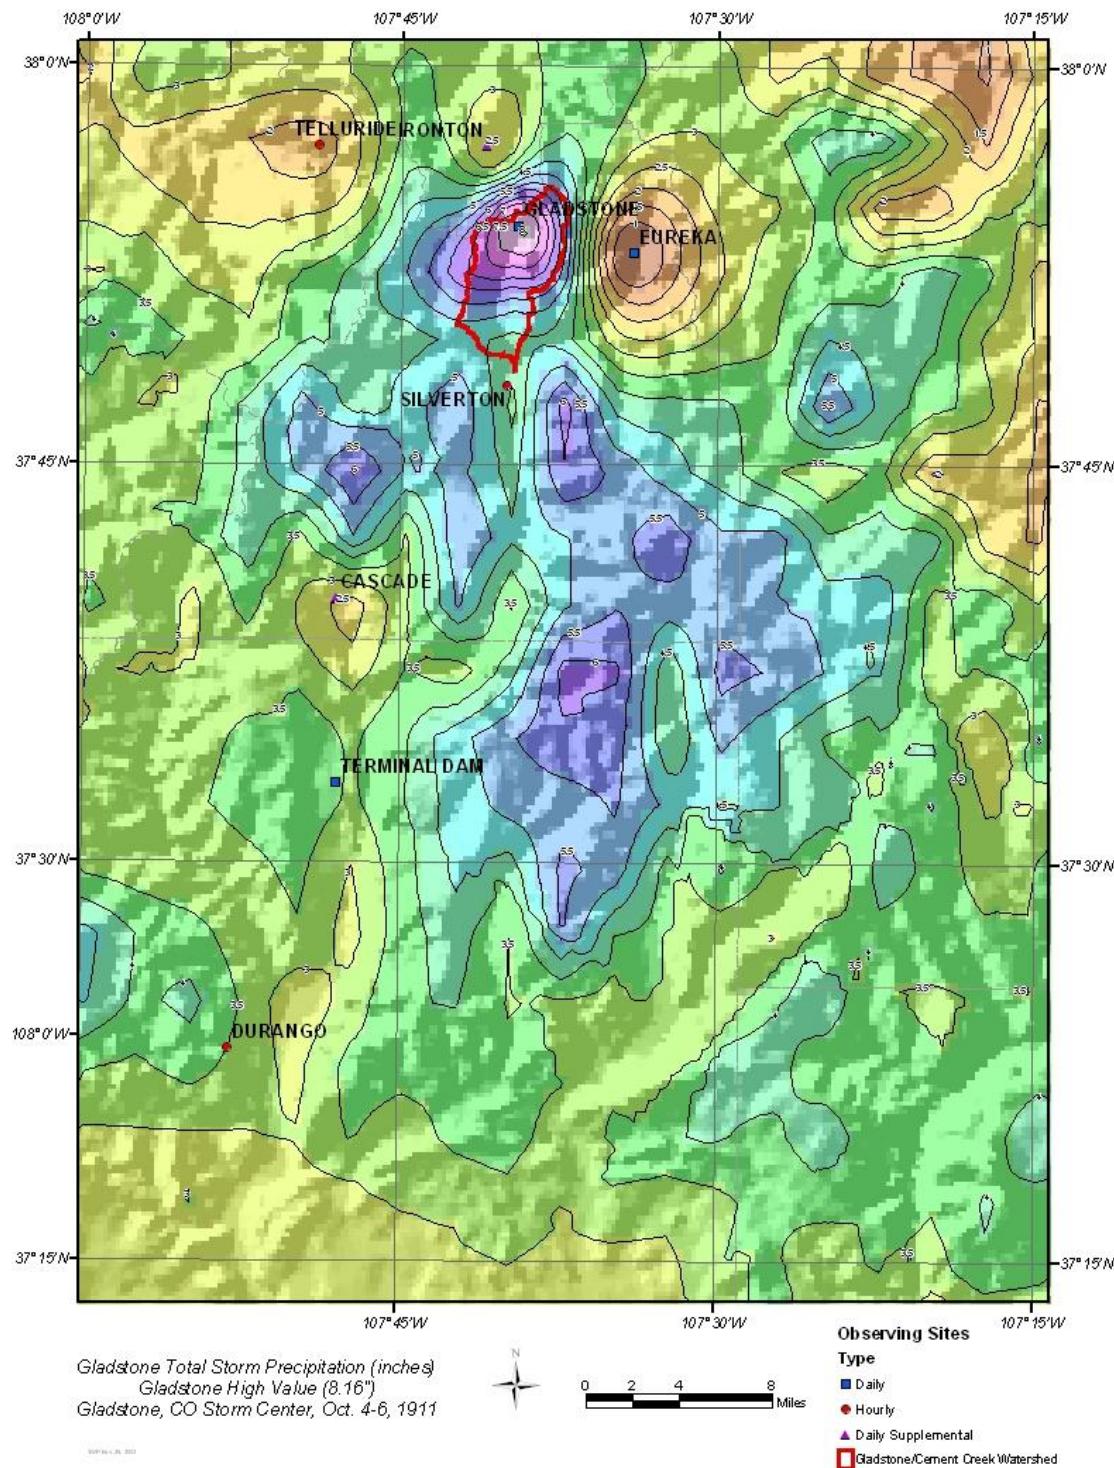
Figure 26. SPAS isohyetal pattern using the Gladstone observation of 8.05" on October 5, referred to as Gladstone "High"

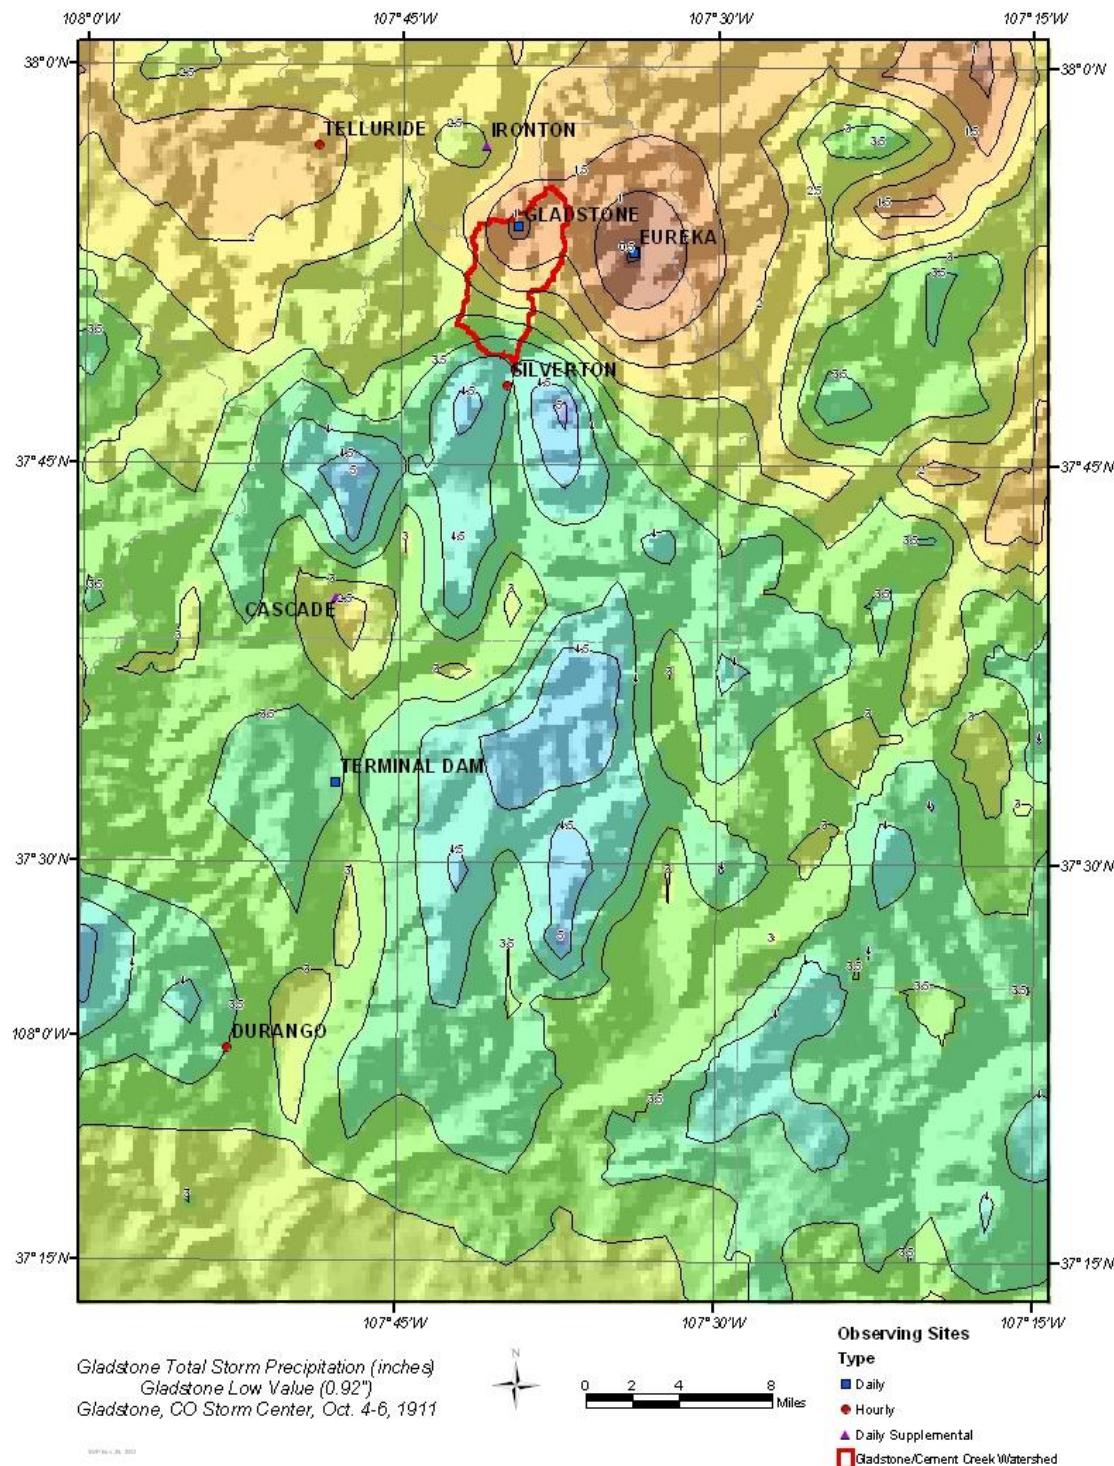
Figure 27. SPAS isohyetal pattern using a rainfall value of 0.81 for Gladstone on October 5, referred to as Gladstone "Low"

* Both Pruess and Crow suggested that the Gladstone observation could have been off by an order of magnitude. Based on this suggestion, the third case used a value of 0.81” for Gladstone on October 5.

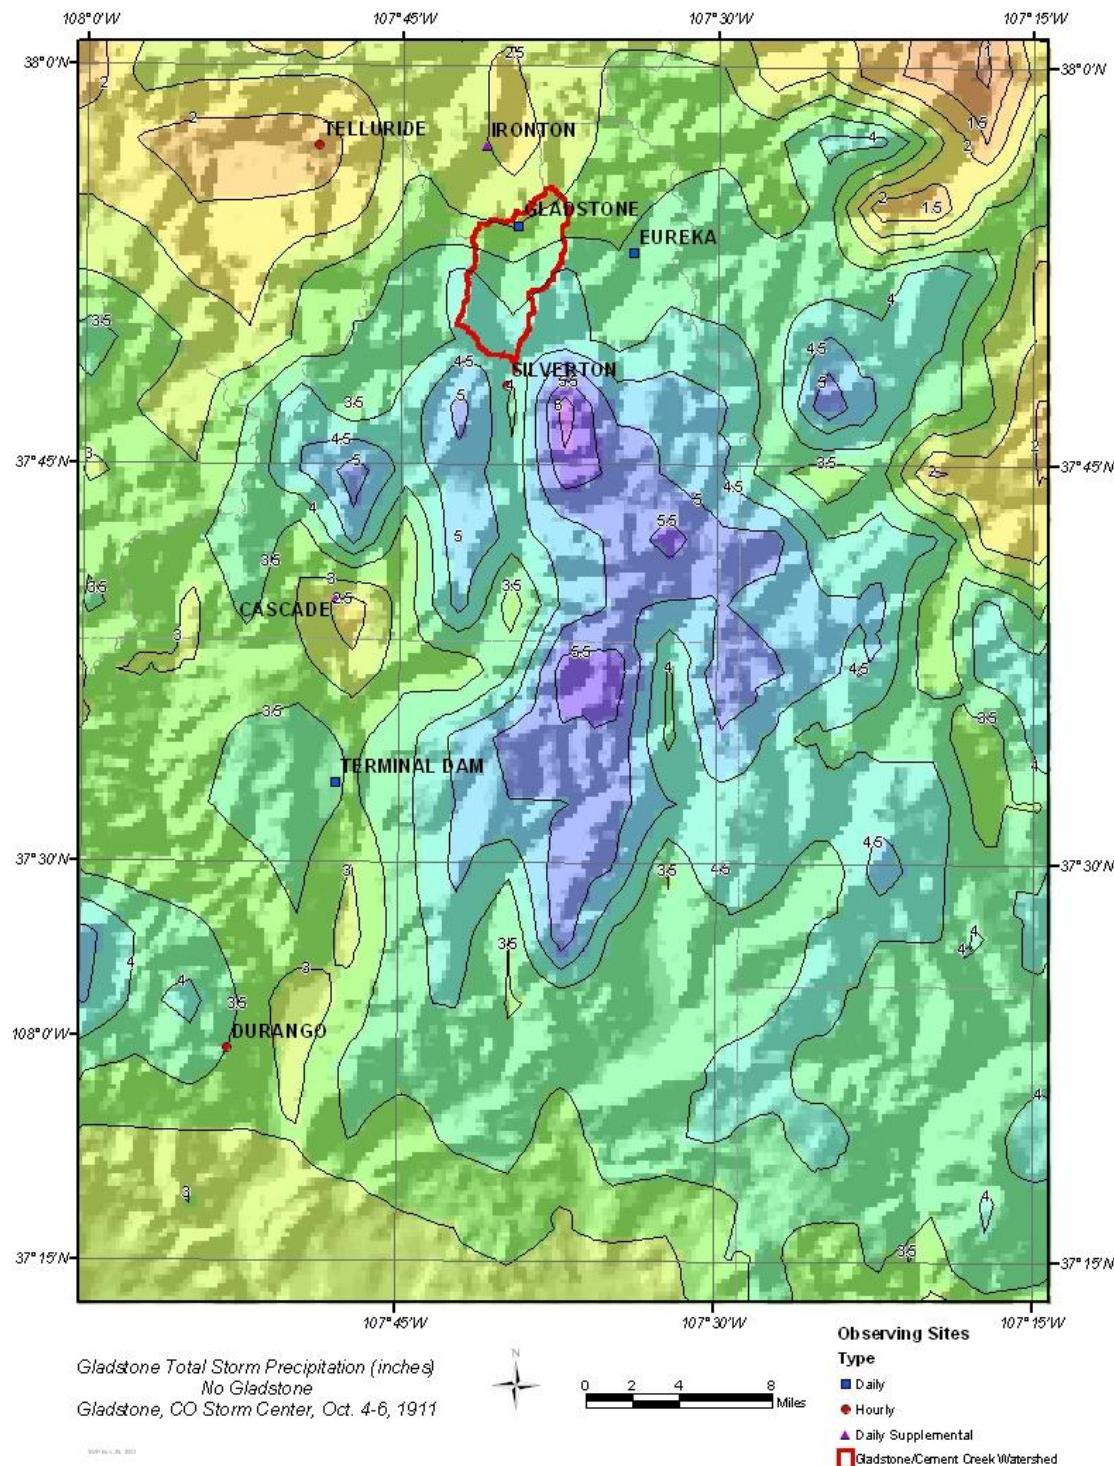
Figure 28. SPAS isohyetal pattern without either the Gladstone or Eureka observations, referred to as w/o Gladstone & Eureka
